Riparian Buffer Review Application
SURFACE WATER IDENTIFICATION REQUEST

Wetland Sketch Map (Post USACE)
Seaforth Site
Chatham County, NC
 Source:
 Chatham County GIS & nconemap.com

SEAFORTH LANDING SURFACE WATER EXHIBIT

CHATHAM COUNTY, NC
APRIL 14, 2015
AKPAR: 17487

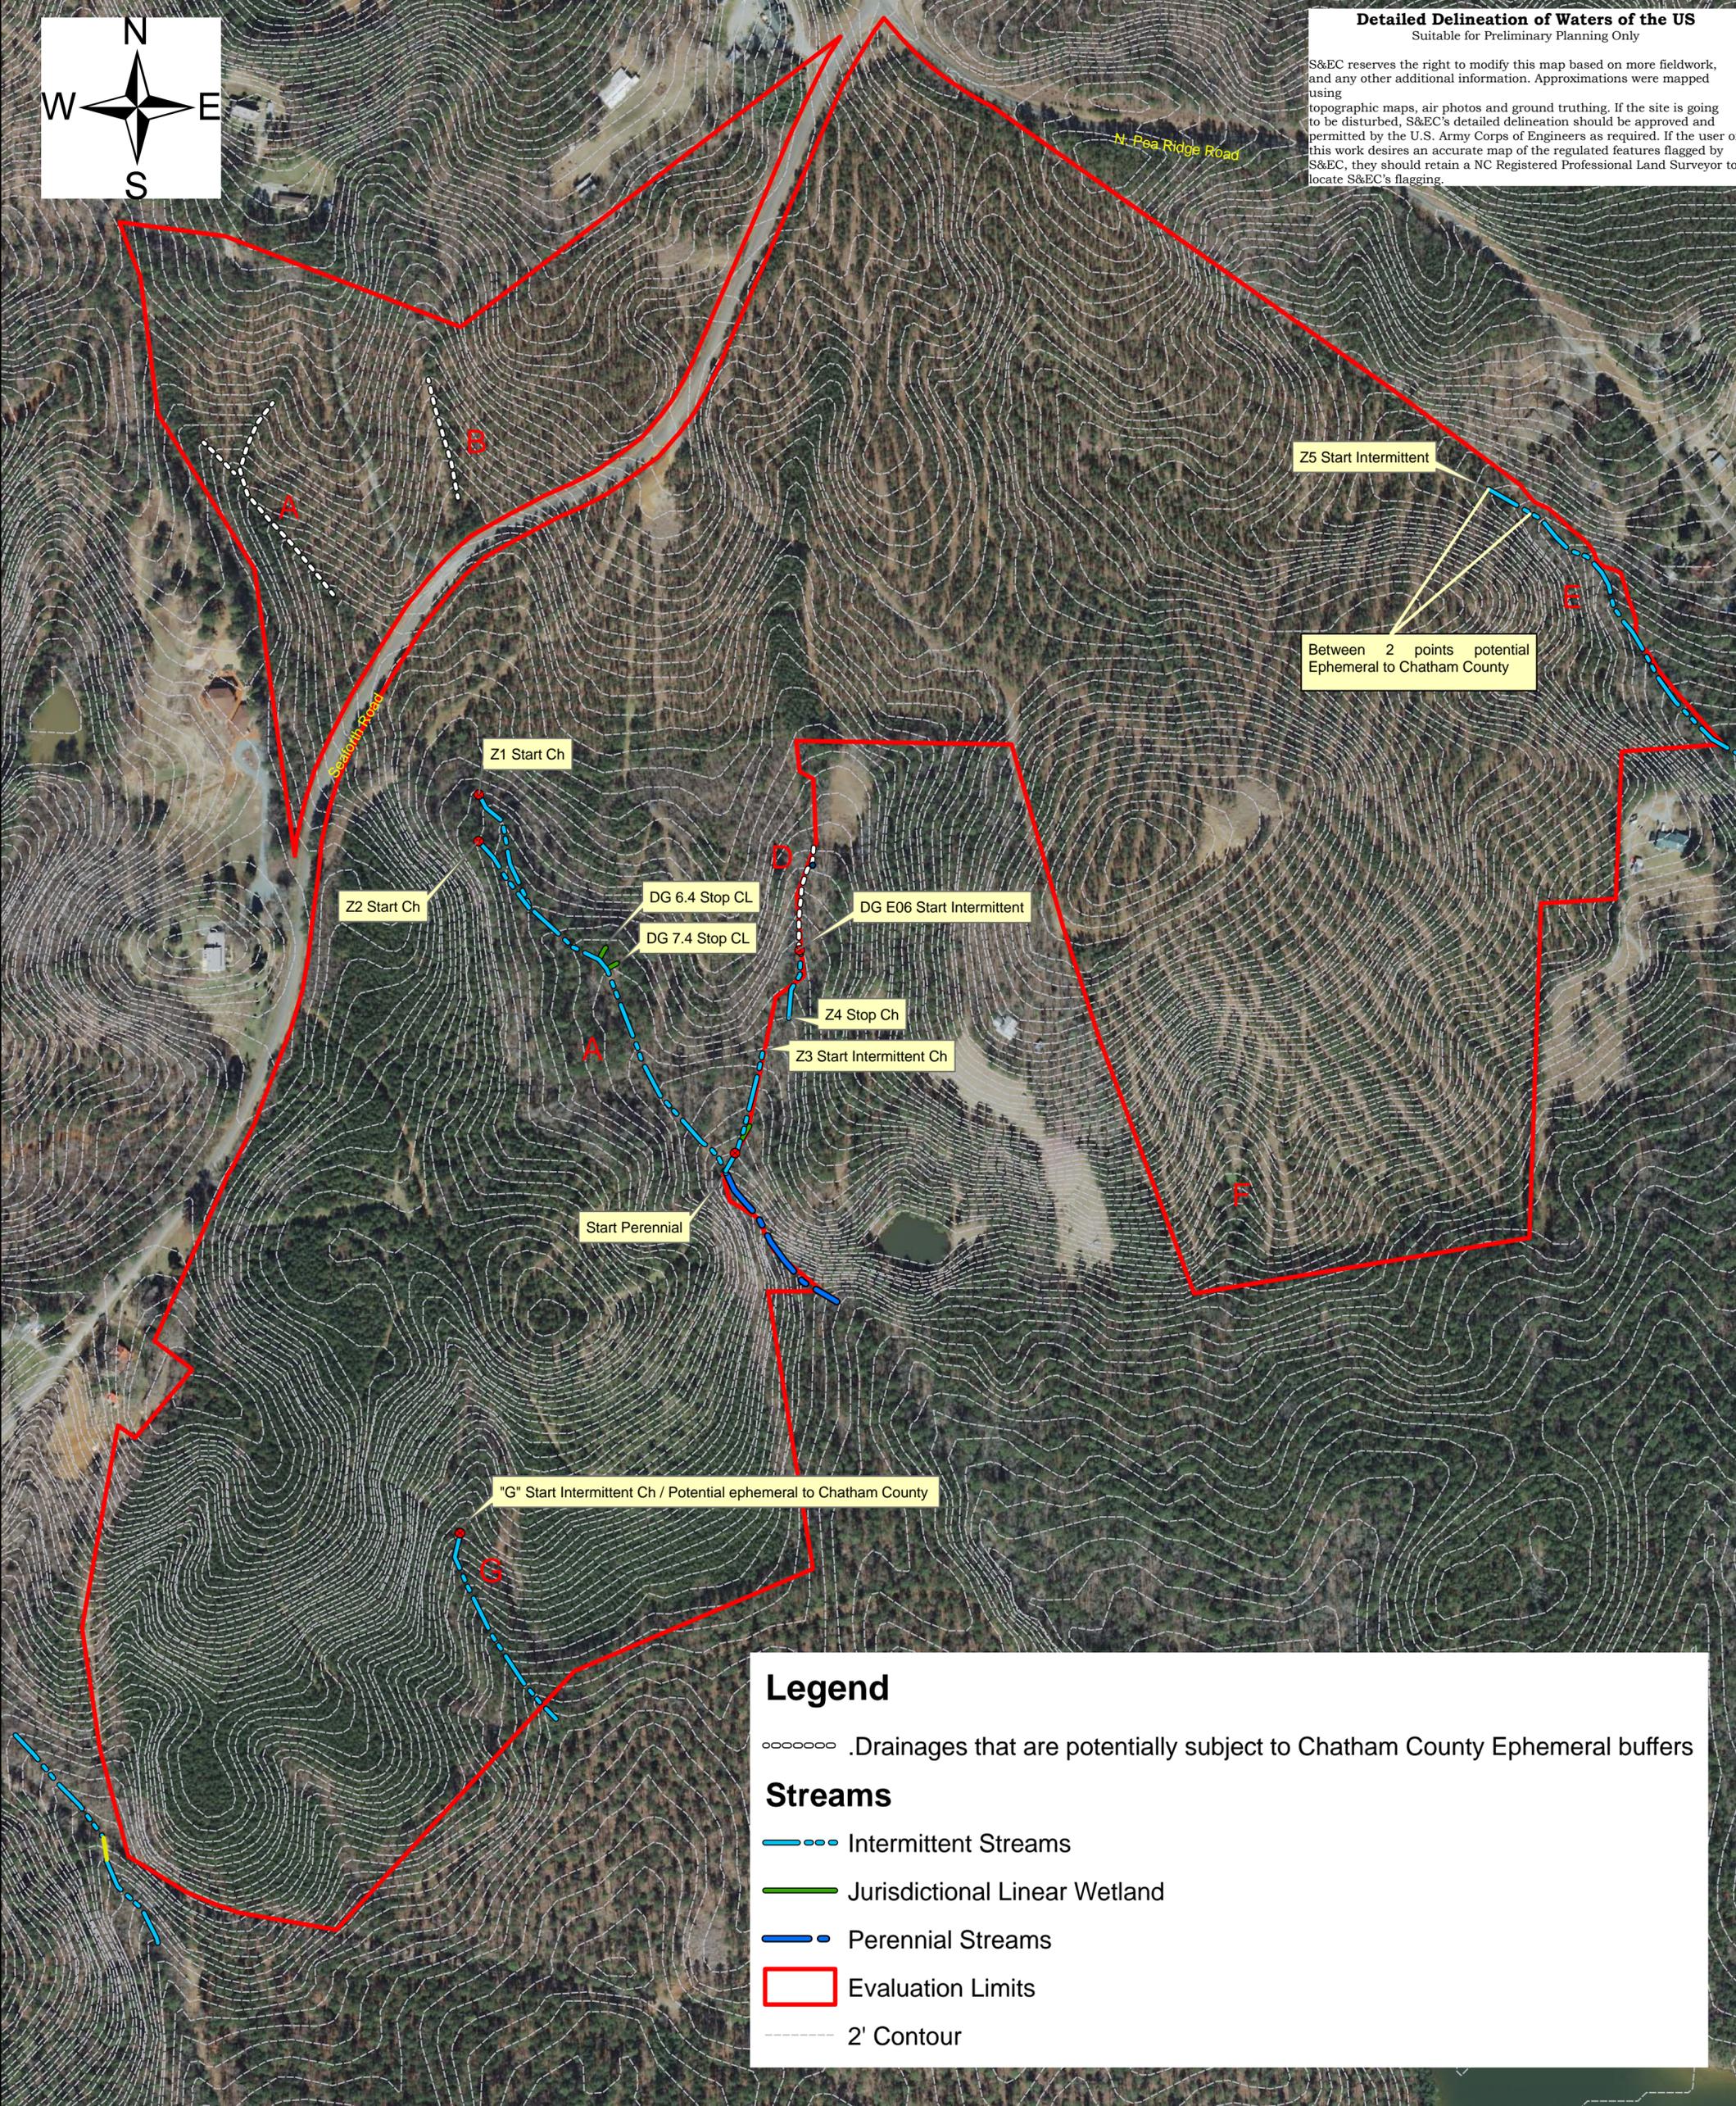
Detailed Delineation of Waters of the US
Suitable for Preliminary Planning Only

S&EC reserves the right to modify this map based on more fieldwork, and any other additional information. Approximations were mapped using topographic maps, air photos and ground truthing. If the site is going to be disturbed, S&EC's detailed delineation should be approved and permitted by the U.S. Army Corps of Engineers as required. If the user of this work desires an accurate map of the regulated features flagged by S&EC, they should retain a NC Registered Professional Land Surveyor to locate S&EC's flagging.

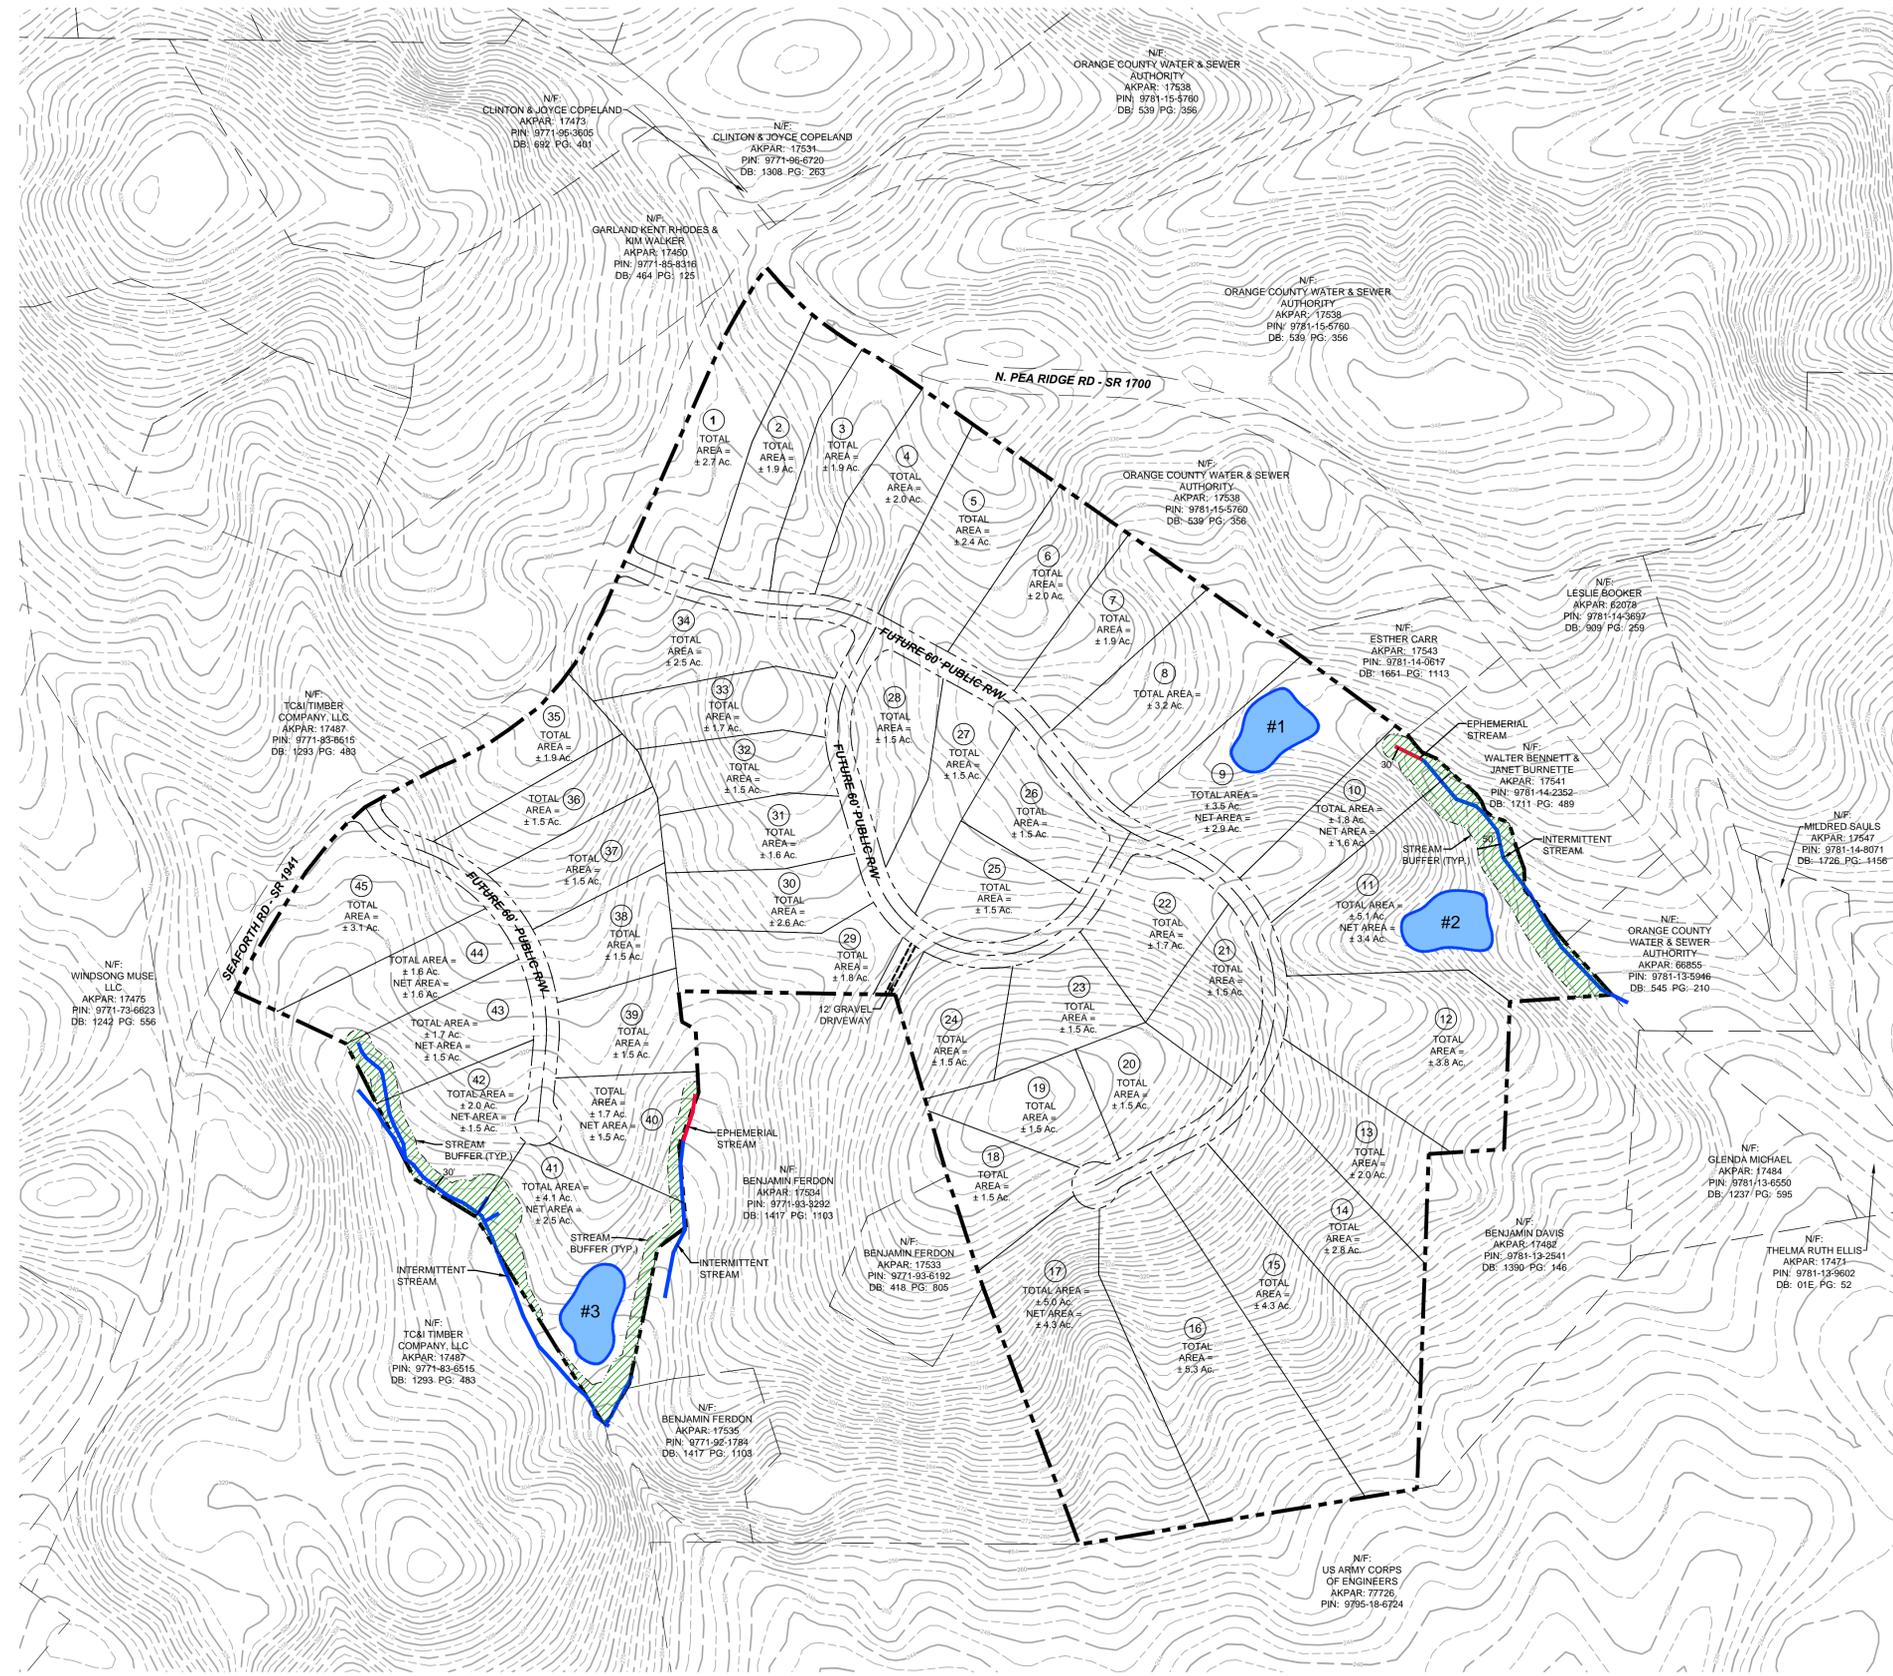
PIN:	9771-83-6515
SITE AREA:	± 107.85 Ac.
TOTAL LOTS:	± 45 LOTS
AVERAGE LOT SIZE:	± 2.2 Ac.
LENGTH OF ROADS:	± 4,989 LF

- APPROXIMATE STREAM BUFFERS
- WATER QUALITY POND

- NOTES:**
1. INFORMATION PROVIDED BY S&EC
 2. STREAM CALLS BASED UPON ACOE FIELD MEETING
 3. EPHEMERIAL CALLS PENDING
