## **Attachment A: Sources of Information and References**

## **Attachment B: Ralph Heath Letter Report**

## **Attachment D: Slug Test Analyses of Piezometers**

**PRELIMINARY  
SUBSURFACE EXPLORATION REPORT  
1200 Acre Assemblage  
Chatham County, North Carolina  
S&ME Project No. 1051-00-273**

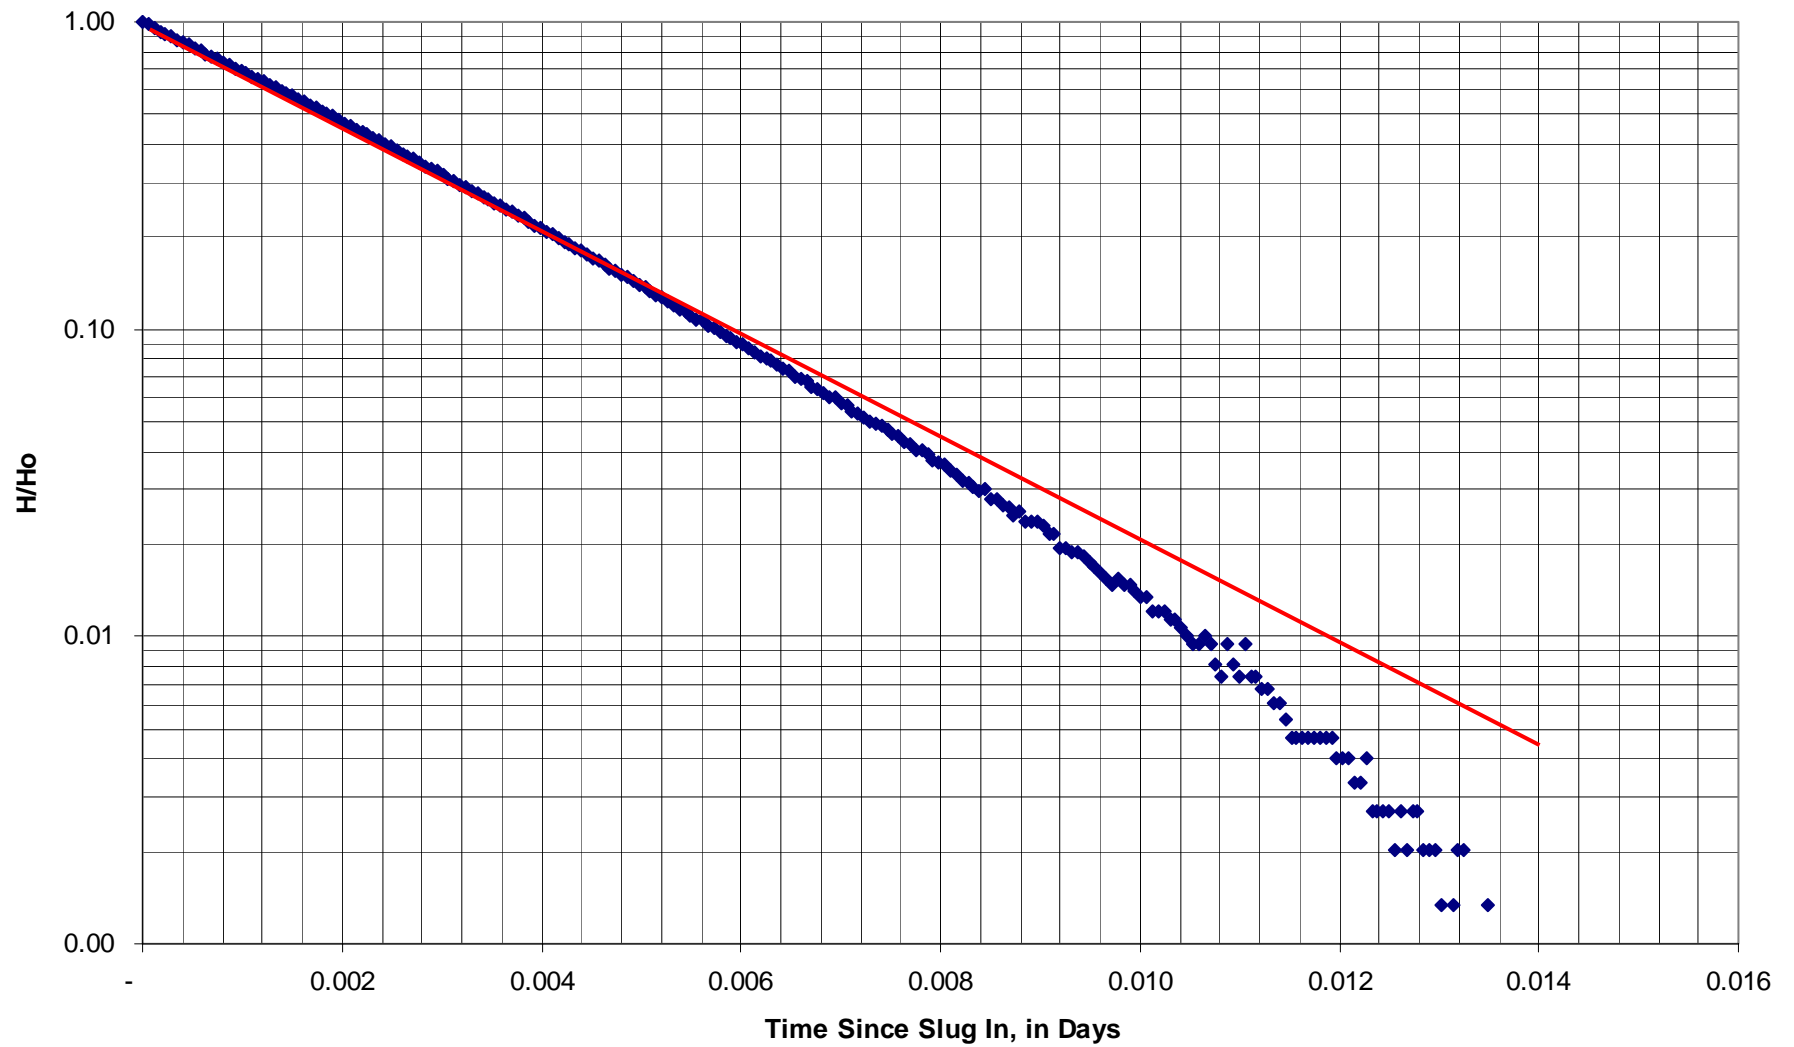
**Figure D-1-- Slug Test Analysis of Piezometer PZ-4  
Briar Chapel Development**

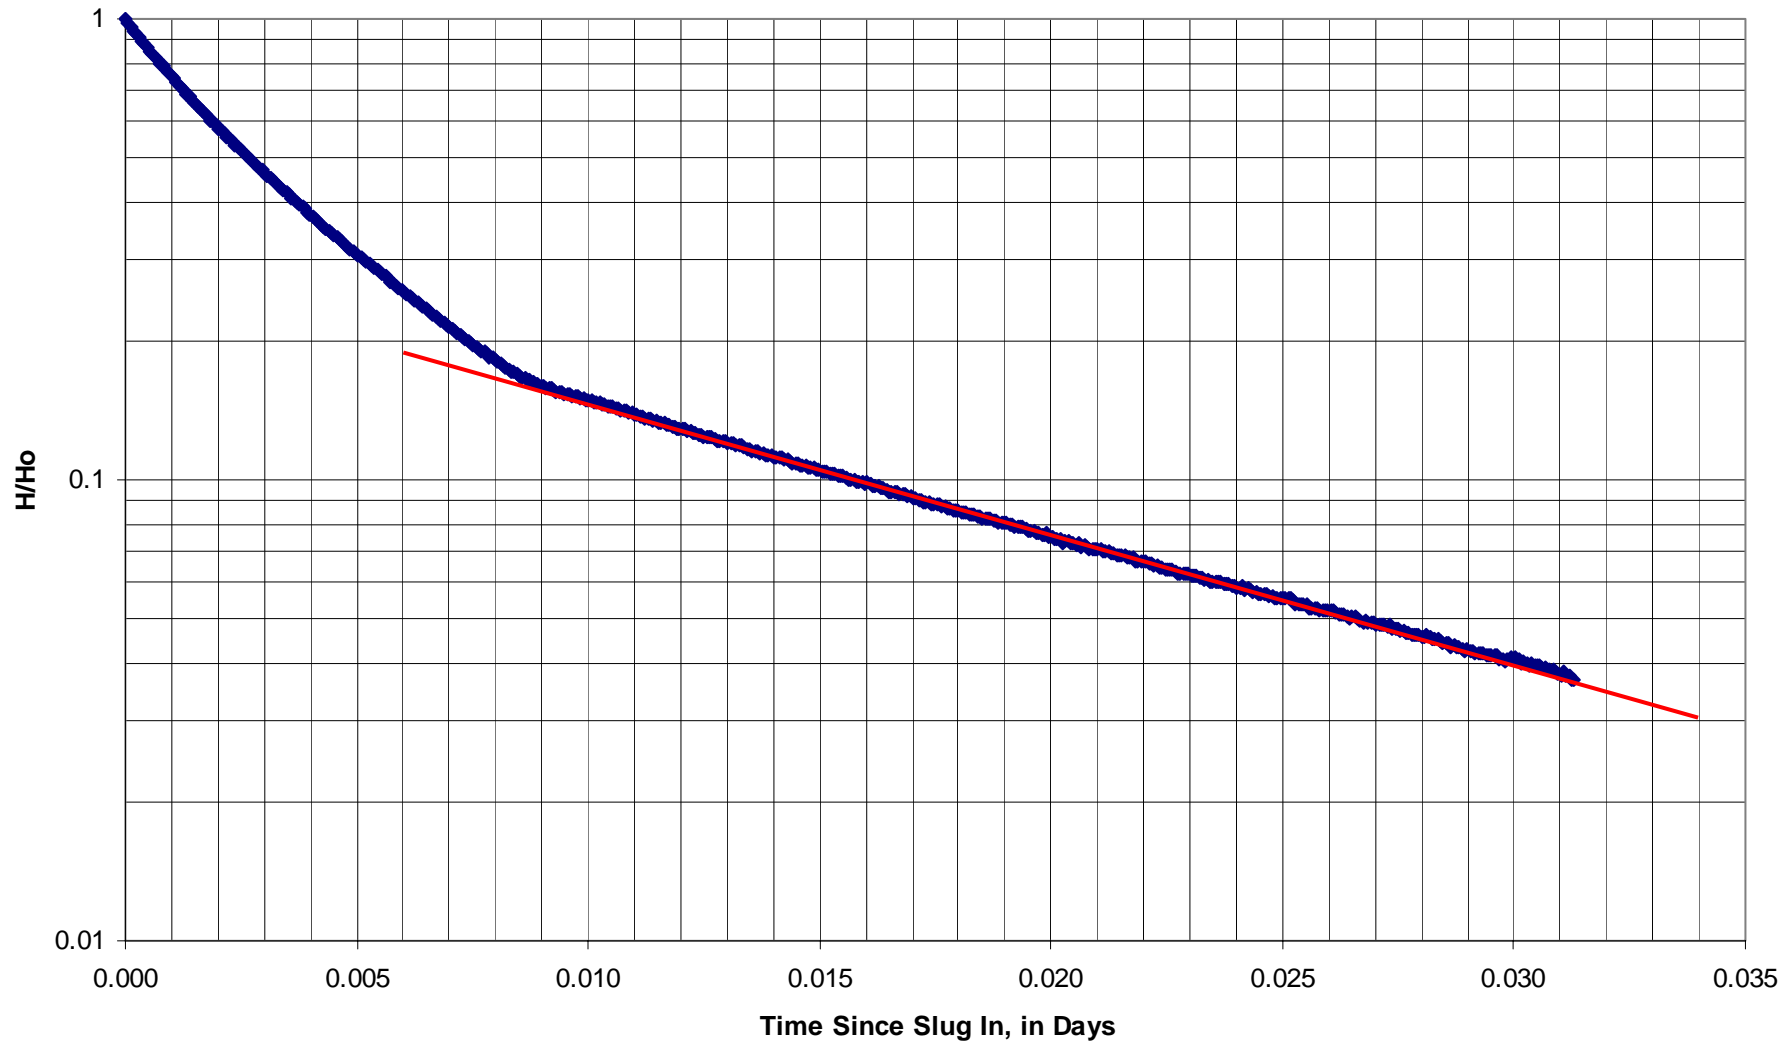
**Figure D-8.--Slug Test analysis of Piezometer PZ-21  
Briar Chapel Development**

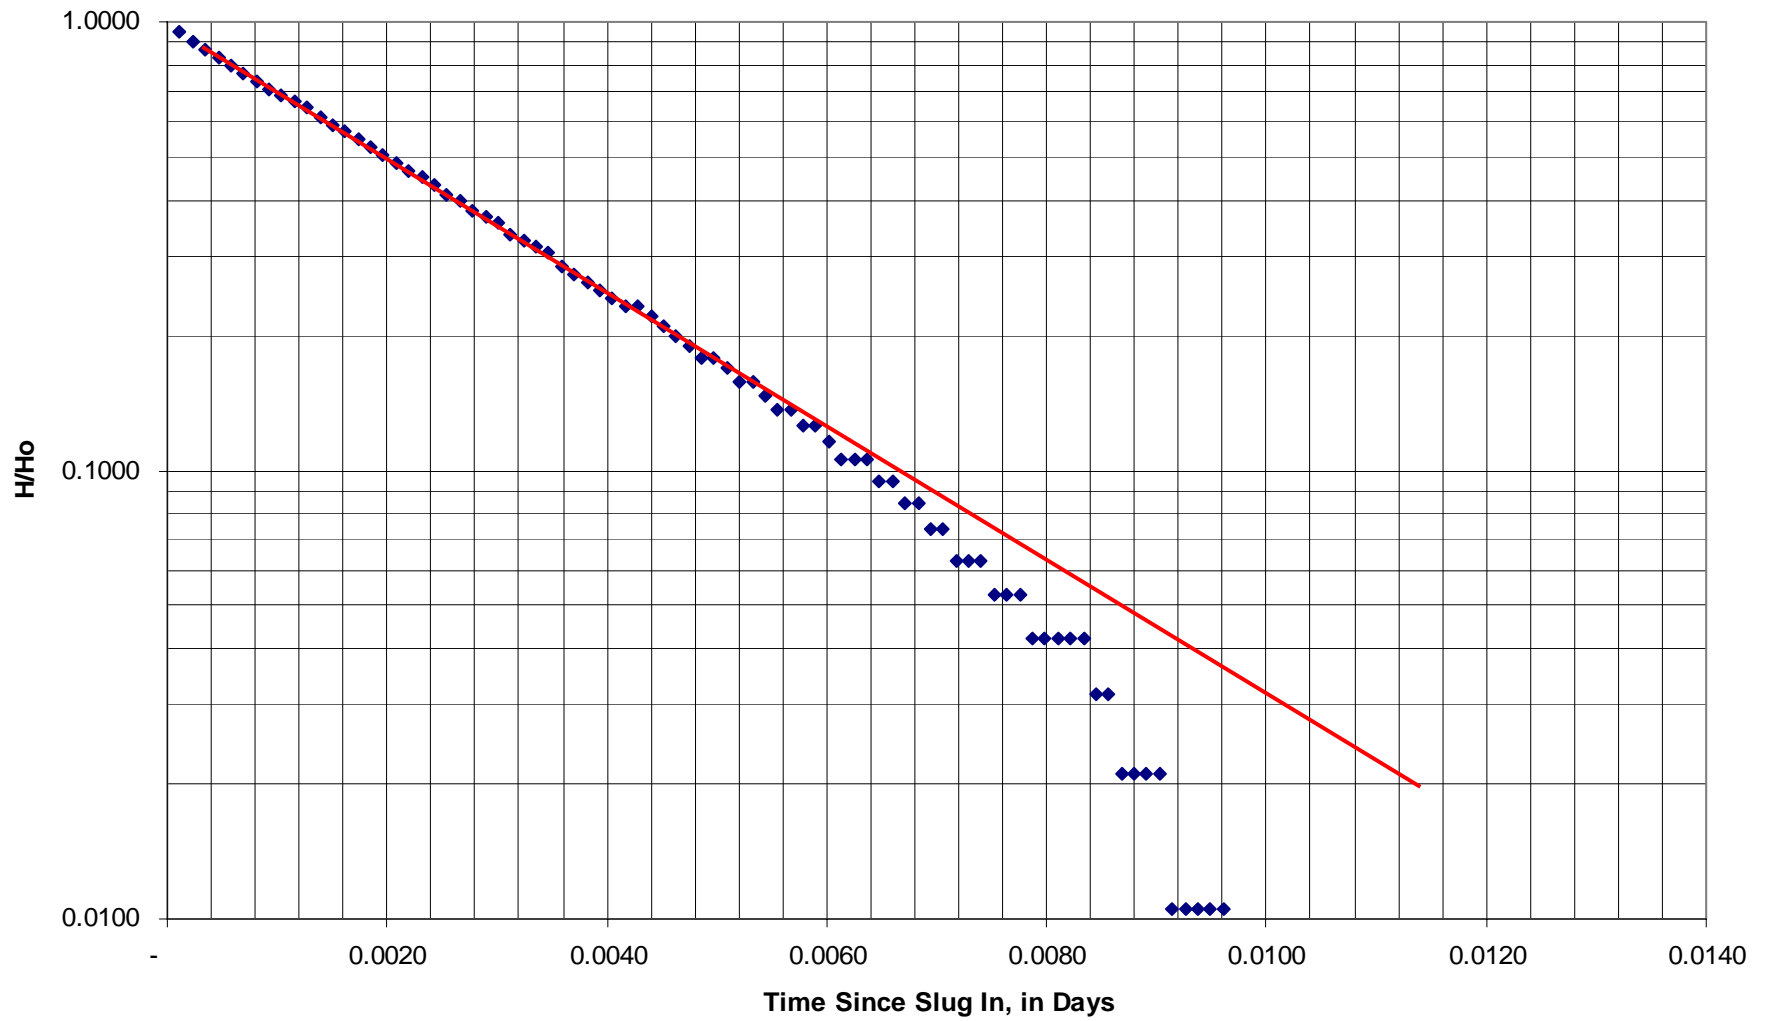
**Figure D-9.-- Slug Test Analysis of Piezometer PZ-23  
Briar Chapel Development**
